## Case Report

# A Rare Central Venous Catheter Malposition in a 10-Year-Old Girl

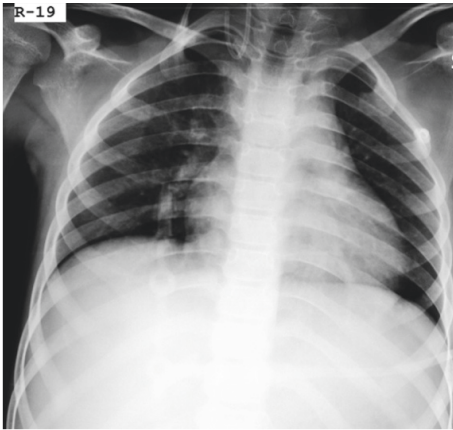
On chest radiograph, the catheter could be seen looping back and going upward at the junction of the right internal jugular vein and the right subclavian vein (Figure 1). The team decided to use ultrasonography to verify that the catheter was

FIGURE 1: The catheter can be seen looping back and going upward at the junction of the right internal jugular vein and the right subclavian vein.

We decided to pull back the catheter under the guidance of ultrasonography until only one lumen could be visualized and then pass a guidewire over the catheter to reposition the catheter. While doing so and after only one lumen was visualized following extraction of the central venous line under the guidance of ultrasonography, passage of the guidewire was attempted, but resistance was encountered. Therefore, we decided to completely remove the catheter and reinsert another catheter.

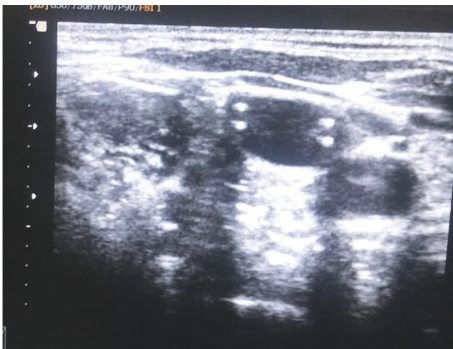
FIGURE 2: The right internal jugular vein is clearly evident on ultrasonography. Two lumens of the catheter can also be seen.

in the jugular vein and had not punctured the dorsal wall of the vein. During scanning of the right internal jugular vein, only a single lumen of the catheter could be seen until we scanned the bottom third of the jugular vein (Figure 2).

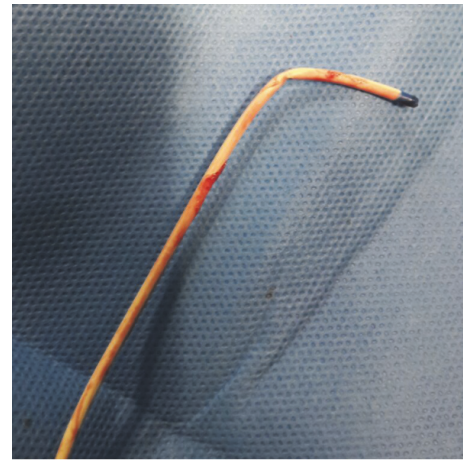
When the catheter was removed, it was observed that the catheter had bent at the distal end (Figure 3).

FIGURE 3: The bended catheter.

Subsequently, we placed another CVC through the internal jugular vein without any complications. The position of the CVC was confirmed by radiograph.

Although we have had different types of malposition of catheters, this is the first time that we encounter a catheter looping back on itself. A probable mechanism could have been the angle of the internal jugular vein and subclavian vein, facilitating the malposition and pushing the j-shaped tip of the guidewire upward and back on itself. The right-sided bevel of the needle at the time of internal jugular vein puncture and guidewire insertion may also have contributed to the looping back of the guidewire and, consequently, the catheter.

It should be noted that a bending catheter has the risk of occlusion or perforation of the vein which fortunately did not occur in the described report above.
