Effect of an Active Open Dumpsite on the Earth's Subsurface and Groundwater Resource

Original Research Article

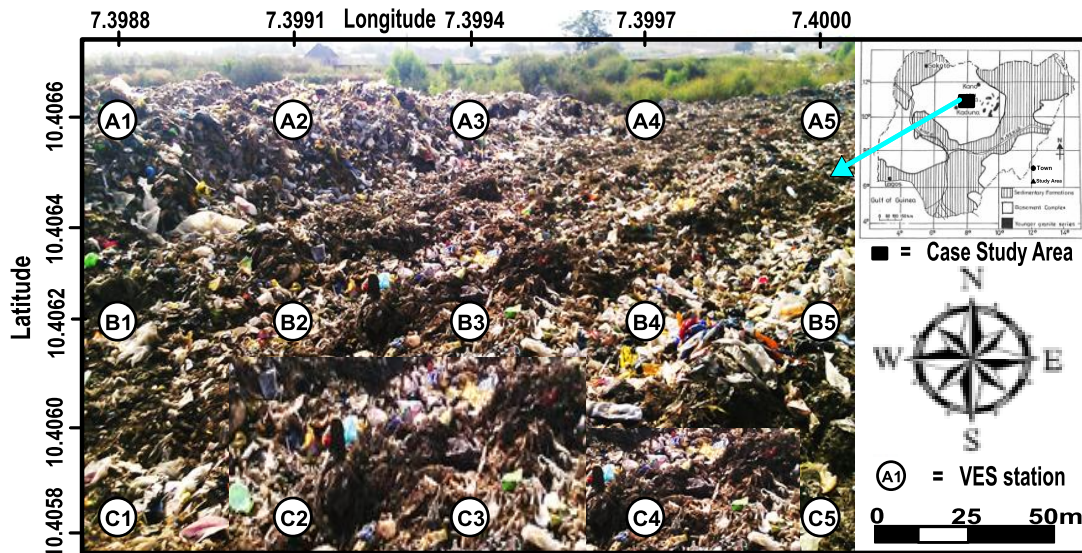
Fig. 1 shows a typical uncontrolled and active open dumpsite located at Goni-Gora, Kaduna, in the basement complex of Nigeria. The dumpsite lies on the geographical coordinates of Latitudes and longitudes 10° 24.393'N to 10° 24.351'N, and 007° 23.955'E to 007° 23.926'E respectively with a total landmass of 24,500 square metres. The open dumpsite has been in operation for more than two decades. The landfill is an undersigned sanitary landfill that is predominant in most parts of the country. The dumpsite is estimated to contain about 56,250 m³ of municipal solid wastes. The open dumpsite contains various wasters such as sewage (human and animal excretion), municipal wastes, medical wastes, agricultural wastes, industrial wastes, and other hazardous wastes.

Fig. 1. Image of the case study of the active open dumpsite showing all the VES Points

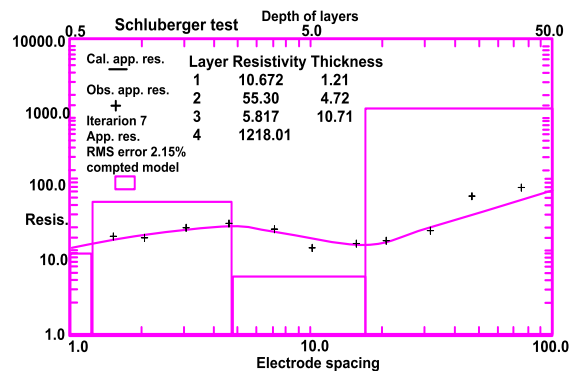
Fig. 3. Typical resistivity curves of VES A2

The first stage in the interpretation of apparent resistivity sounding curves is to note the curve type before applying *Res ID version 1.00.07* Beta software [22,24,30,31]. The Micro-soft excel was used to initiate the rough idea of the expected curve after the data collected was reduced and computed. The subsurface geo-electrical data obtained from Res 1D were utilized to generate the depth sections. Fig. 3 shows the resultant curve for the VES station A2 along with profile A (Fig. 3). However, the measurement of resistivity is based on the difference in the subsurface resistivity values of the model blocks between the measured and calculated apparent resistivity values from the field. Consequently, the accuracy of fit is expressed in terms of the root mean square (RMS) error [12,13,22,23,26].
