Atmospheric Corrosion of Al-Zn Coated Steel Sheets Exposed under Marine Environments in Kenya

Original Research Article

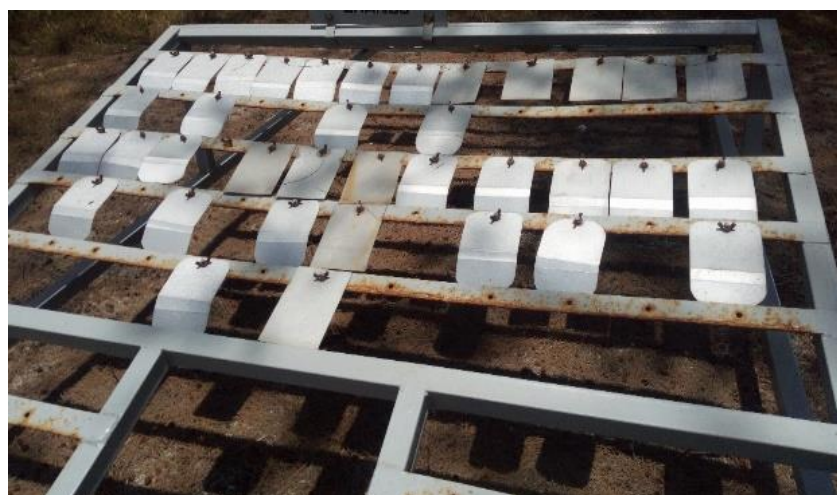
The initial coating mass was recorded before exposure to the atmosphere, then the racks were inclined at an angle of 45° facing the sea for a period of 2 years according to ASTM G50-76 [18]. Fig. 2 illustrates the racks exposed during experimental period. Representative samples of exposed specimen were collected at intervals of 3 months over the experimental period and analysed to determine losses in coating mass.

Fig. 2. A set-up for outdoor exposure of 55% Al-Zn metallic coated sheets at Diani site

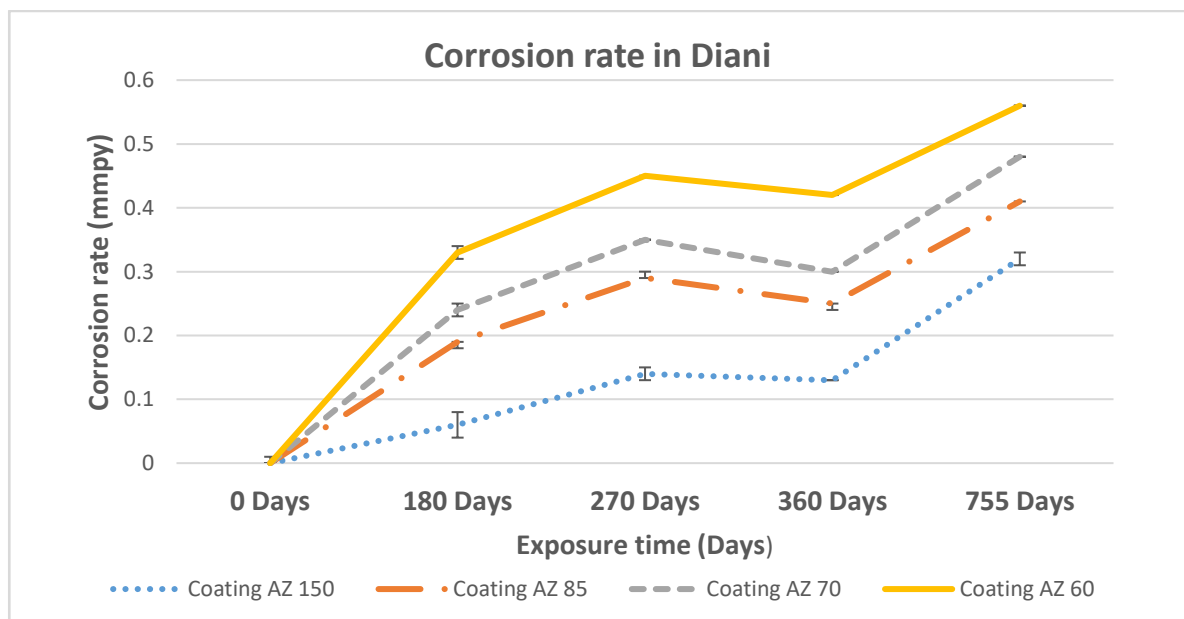
All the specimen exposed at Diani site experienced high corrosion rates compared to Mariakani site. Corrosion rate increased from AZ150<AZ85<AZ70<AZ60 suggesting a reduction of the rate of corrosion with increasing mass of coating materials. In addition, the high rate of corrosion at Diani was attributed to high levels of chlorides in the atmosphere compared to Mariakani which was located over 40 km away. The findings agree with the earlier studies by Zhao and coworkers [22] who found corrosion rate up to 80 times due to presence of chlorides. Chloride ions get adsorbed on the protective oxide layer and reacts with the metal surface to form intermediate soluble complexes that accelerate corrosion. The observed fluctuating rate of corrosion at different stages of the experiment could be attributed to the formation and removal of corrosion film products from the surface of the iron sheets which agrees with the findings of Natesan and coworkers [10]. Fig. 4 illustrates corrosion of AZ iron sheets covered with different degrees of coating materials that were exposed at Diani site.

Fig. 4. Corrosion rate of AZ metallic coated iron sheets at Diani

Diani site due to its proximity to the ocean experienced higher levels of relative humidity (81%), UV radiation (12 mW/cm^2), temperature (27°C) that accelerated corrosion. Similar findings were reported by Syed [23] Vashi and Kadiya [24] and Wallinder and Leygraf [25].

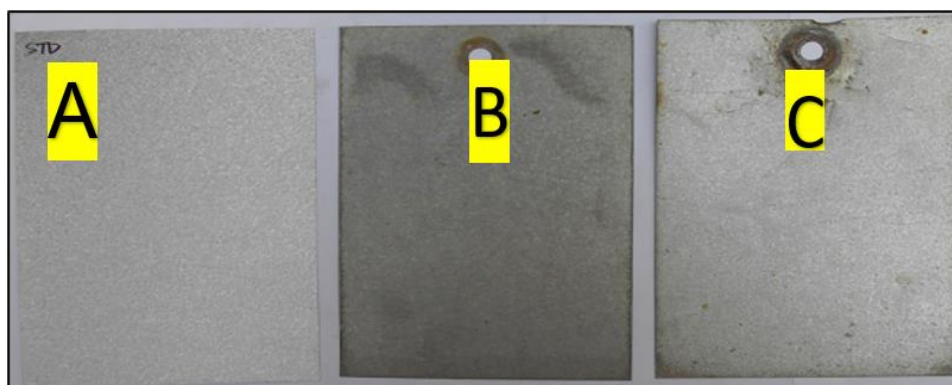
Fig. 5 illustrates the visual impression of the sampled specimens A, B and C after a 2-year exposure at Diani and Mariakani sites. The specimen exposed at Mariakani site were darker due to exposure to vehicular emissions. The specimen exposed to the environment recorded greyish colouration on the surface.

Fig. 5. A photograph showing comparison of corroded specimen (AZ 150) at Mariakani and Diani test sites (A)-control specimen, (B) - Mariakani specimen and (C) - Diani site specimen).

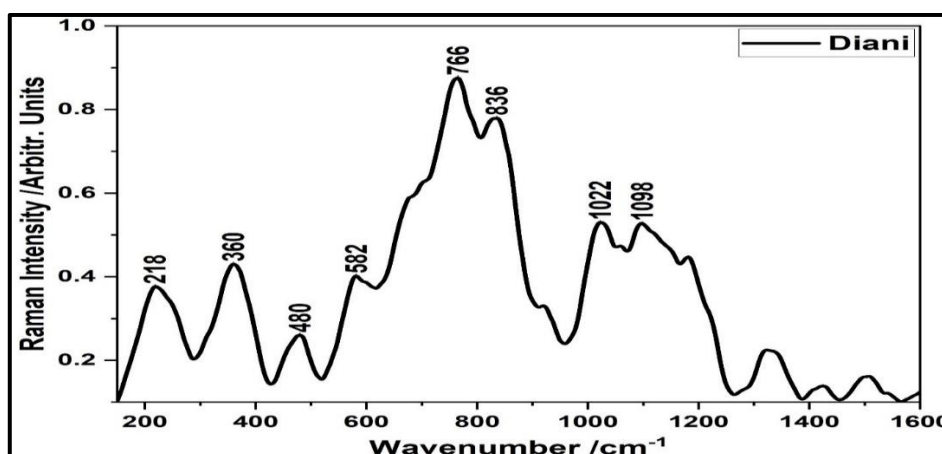
Raman spectra of corrosion products after a 2 year of exposure to severe marine environment at Diani revealed the presence of goethite (α -FeOOH), maghemite (γ -Fe₂O₃), akaganeite (β -FeOOH), lepidocrocite (γ -FeOOH) and hematite (α -Fe₂O₃) (Fig. 6). The Raman spectra bands at 480, 1116, 1176, and 1508 cm⁻¹ were associated with Goethite. Maghemite presented strong spectra at 346 and 766 cm⁻¹ at Diani and Mariakani, respectively. Lepidocrocite γ -FeOOH spectra were at bands 392 and 1098 cm⁻¹.

Fig. 6. Raman spectra of AZ metallic coated steel exposed at Diani site

Akaganeite (β -FeOOH) had a spectrum at 582 and 548 cm^{-1} for Diani and Mariakani, respectively. Maghemite and Akaganeite are considered as the primary corrosion products at marine environment. The presence of Akaganeite is as a result of chlorinated compounds (oxyhydroxide Akaganeite) hence the influence from the sea salt. However, the presence of SO_2 in the atmosphere forms mildly acidic environment which makes $\text{Fe}(\text{OH})_2$ not to precipitate [33]. Due to the distance from the Indian Ocean, reduction of oxygen could have led to formation of magnetite at Mariakani site.

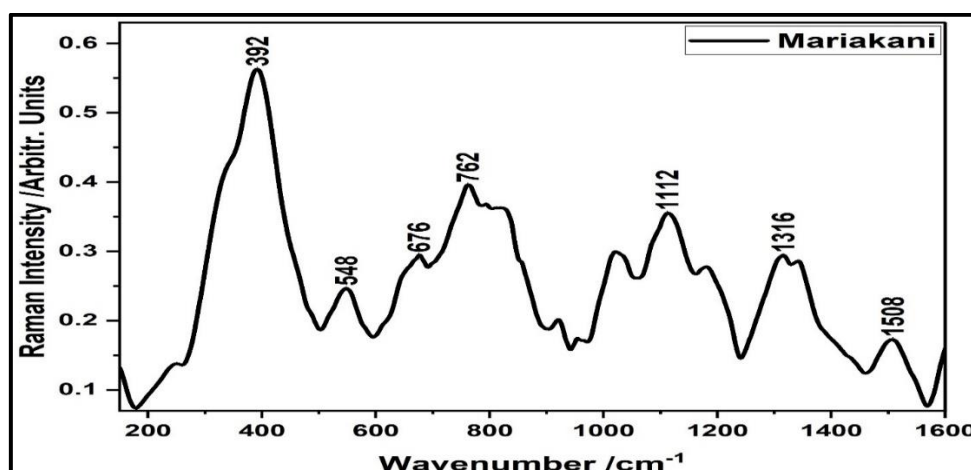
The sheets exposed displayed phases of goethite, akaganeite, magnetite, maghemite, lepidocrocite and hematite (Fig. 7). Magnetite (Fe₃O₄) band was observed only at Mariakani at a band of 676 cm⁻¹. Formation of (Fe₃O₄) is more likely when there is limited oxygen supply which leads to the environment becoming more reducing [32].

Fig. 7. Raman spectra of AZ metallic coated steel exposed at Mariakani site
